Miscellaneous Paper CERC-96-3  
May 1996

# Physical Model Study of Breakwater Stability, Kodiak, Alaska

Prepared for U.S. Army Engineer District, Alaska

**Final report**

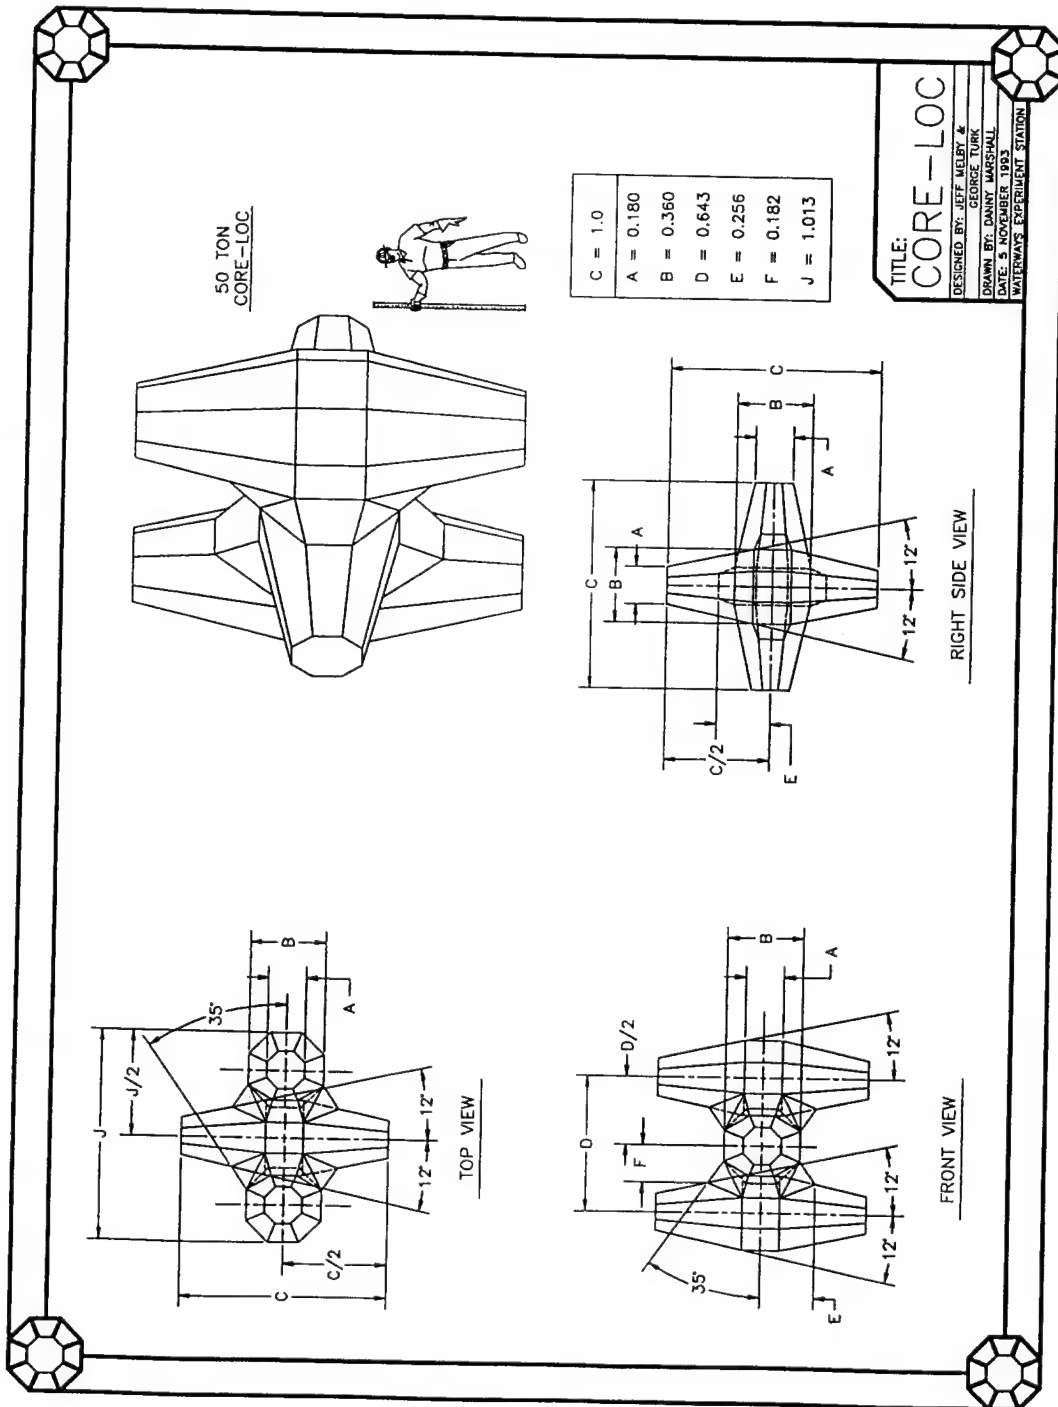
Figure 2. Core-Loc concrete armor units

Preliminary analysis conducted at NPA indicated a 500-kg (1,100-lb) Core-Loc would be hydraulically stable under incident conditions of the open-ocean wave with a height of 2.1 m (7 ft) and period of 14 sec. Using larger armor units would result in higher concrete costs but lower placement costs due to fewer units being required, with 1,350-kg (3,000-lb) Core-Locs providing the lowest total cost. Model tests were therefore conducted using scaled model units representing 1,350-kg (3,000-lb) prototype units.

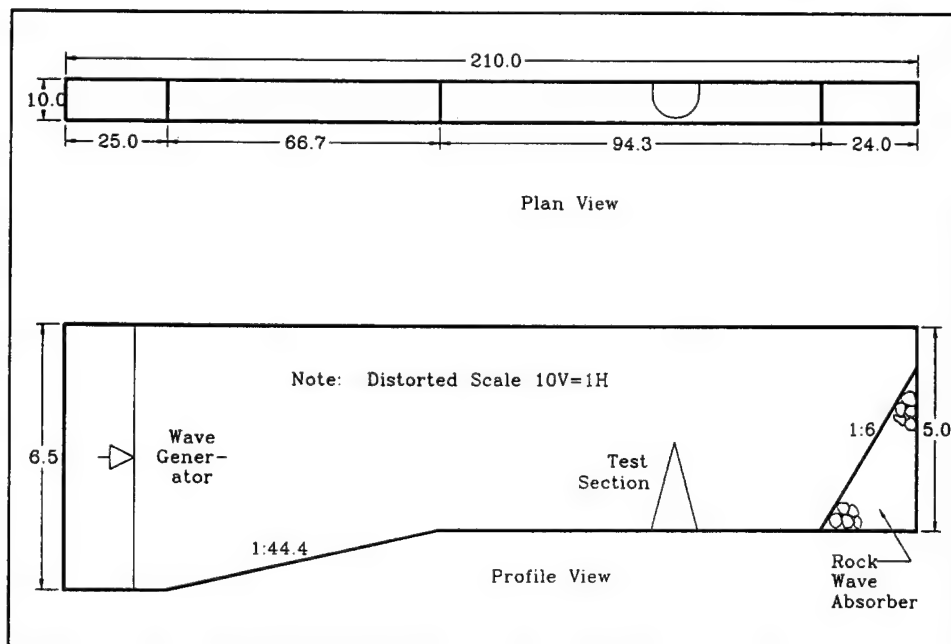
Figure 4. Two-dimensional test flume

Physical model tests were conducted in a 64-m-long (210-ft-long) by 3.0-m-wide (10-ft-wide) wave flume (Figure 4). The flume includes a 36-m-long (118.3-ft-long) by 1.5-m-deep (5-ft-deep) test section, then slopes at 1V:44.4H to a depth of 2.0 m (6.5 ft) at the wave generator. Waves were generated by a piston-type wave board powered by an electro-hydraulic pump controlled by a computer-generated signal. Capacitance-type wave gauges were placed in a three-gauge array in front of the wave board to record the generated wave train, with another three-gauge array located in front of the test structure to record wave trains near the structure. Three-gauge arrays were

used to permit separation of incident and reflected wave trains by the method of Goda and Suzuki (1976).<sup>1</sup> Flume bottom was set at -9.1 m (-30 ft) mllw. Bathymetry was not molded into the flume.

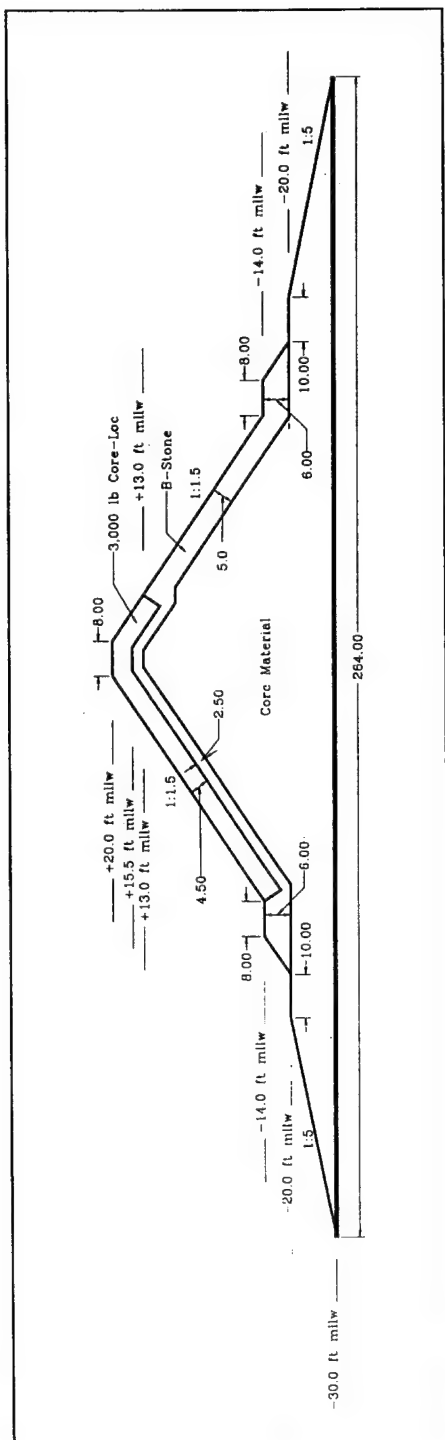
Figure 5. Cross section of breakwater trunk, Plan 1

B-stone in the original plans (with stone as primary armor units) was specified as 140 to 770 kg (300 to 1,700 lb) with  $W_{50} = 340$  kg (750 lb). With the change to Core-Locs, size of the B-stone was reduced to 140 to 270 kg (300 to 600 lb). Core-Locs were placed on the structure head and on the sea side of the structure trunk, then across the crest of the trunk and down the harbor side to +4.0 m (+13 ft) mllw. B-stone was used for the underlayer beneath Core-Locs and for outer armor stone on the harbor-side trunk below +4.0 m (+13 ft) mllw. A cross section of the model trunk (in prototype units) is shown in Figure 5; a cross section of the model head is shown in Figure 6. Photos 5, 6, and 7 show Plan 1 before testing from sea side, end view, and harbor side, respectively.

Plan 2 used the same cross sections as Plan 1 (Figures 5 and 6), but replaced B-stone on the harbor-side trunk with larger B-stone weighing 140 to 770 kg (300 to 1,700 lb) with  $W_{50} = 340$  kg (750 lb) to stabilize the harbor-side trunk. B-stone beneath Core-Locs was not replaced. All Core-Locs were removed from the structure crest and harbor side, but structure head and sea-side slope were not rebuilt. Due to settling and compacting of Core-Locs on the head and sea-side slope, 15 additional Core-Locs were required to rebuild the structure crest. The first row of Core-Locs above B-stone on the harbor-side trunk was not uniformly placed as in Plan 1, but stones were randomly placed for the entire rebuild of the structure.

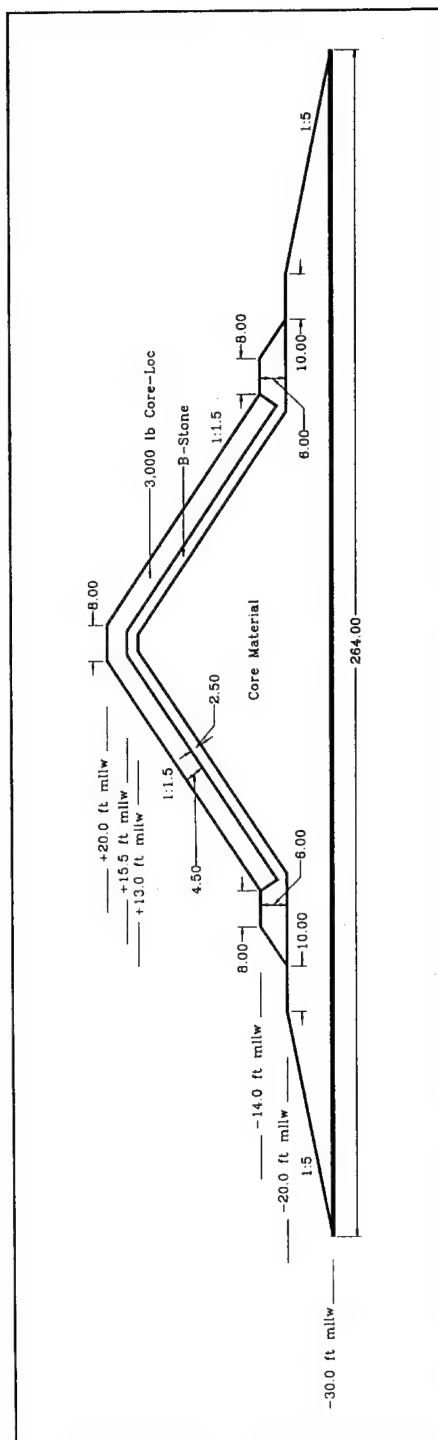
Figure 6. Cross section of breakwater head, Plan 1

Plan 3 used the same cross section as Plans 1 and 2 for the head (Figure 6), but extended Core-Locs on the harbor-side trunk from the crest down to 0.0 m (0.0 ft) mllw (Figure 7). In Plan 1, Core-Locs extended from the crest only down to +4.0 m (+13 ft) mllw. B-stone used in Plan 1 on the harbor-side trunk again was used on Plan 3, replacing the larger B-stone used on Plan 2. NPA expressed concerns about availability of larger B-stone and preferred a design using smaller stone.

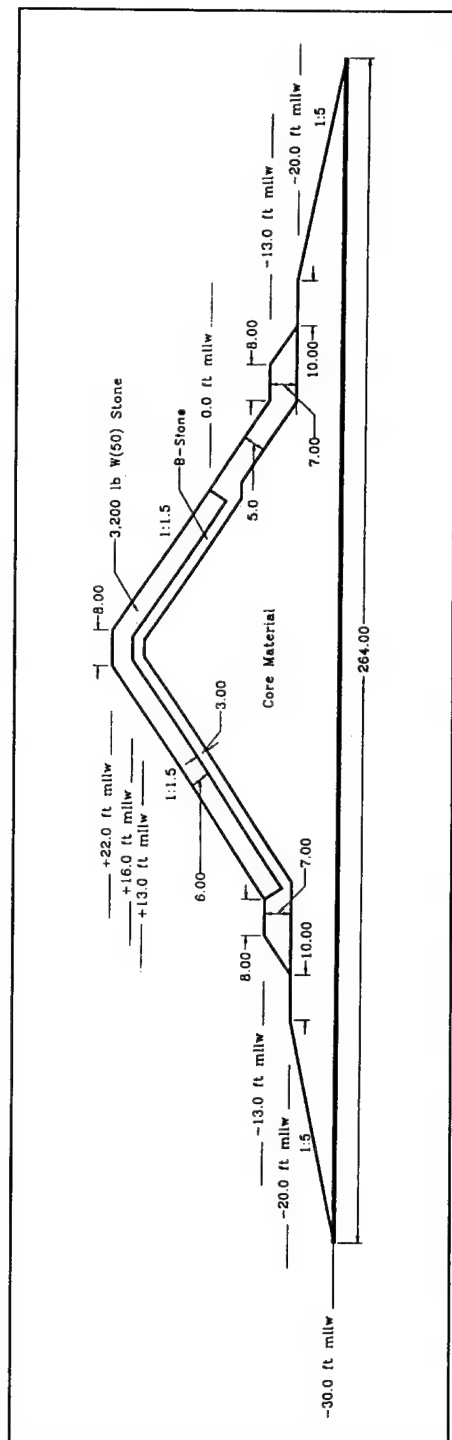
Figure 8. Cross section, breakwater trunk, Plan 5

Plan 5 used armor stone instead of Core-Locs for primary armoring of the structure. All Core-Locs were removed from the structure and the underlayer was smoothed and reshaped as necessary. A double layer of armor stone with  $W_{50} = 1,450$  kg (3,200 lb) was placed over the B-stone underlayer. Crest elevations of the structure core and underlayer were the same as in Plans 1, 2, 3, and 4, but the double layer of armor stones raised the final crest elevation higher than the single layer of Core-Locs used on earlier test configurations. Stones were placed in a manner similar to dropping each stone individually from a backhoe, and no attempt was made to specially place or key the stones. Stones used on the model were more uniform in size than would be expected on the prototype, with model stones typically within  $\pm 10$  percent of  $W_{50}$ . Figure 8 shows a cross section of the Plan 5 trunk; Figure 9 shows a cross section of the Plan 5 head. The vertical panels of rubberized matting used in Plan 4 were used again in Plan 5. Photos 20, 21, and 22 show sea-side, end, and harbor-side views, respectively, of Plan 5 before testing.

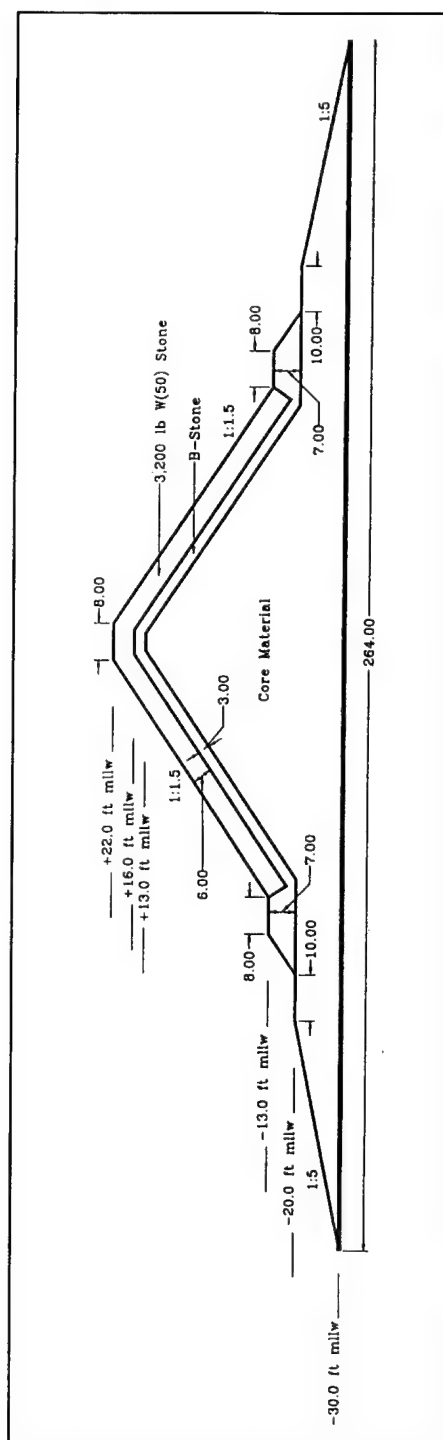
Figure 9. Cross section, breakwater head, Plan 5

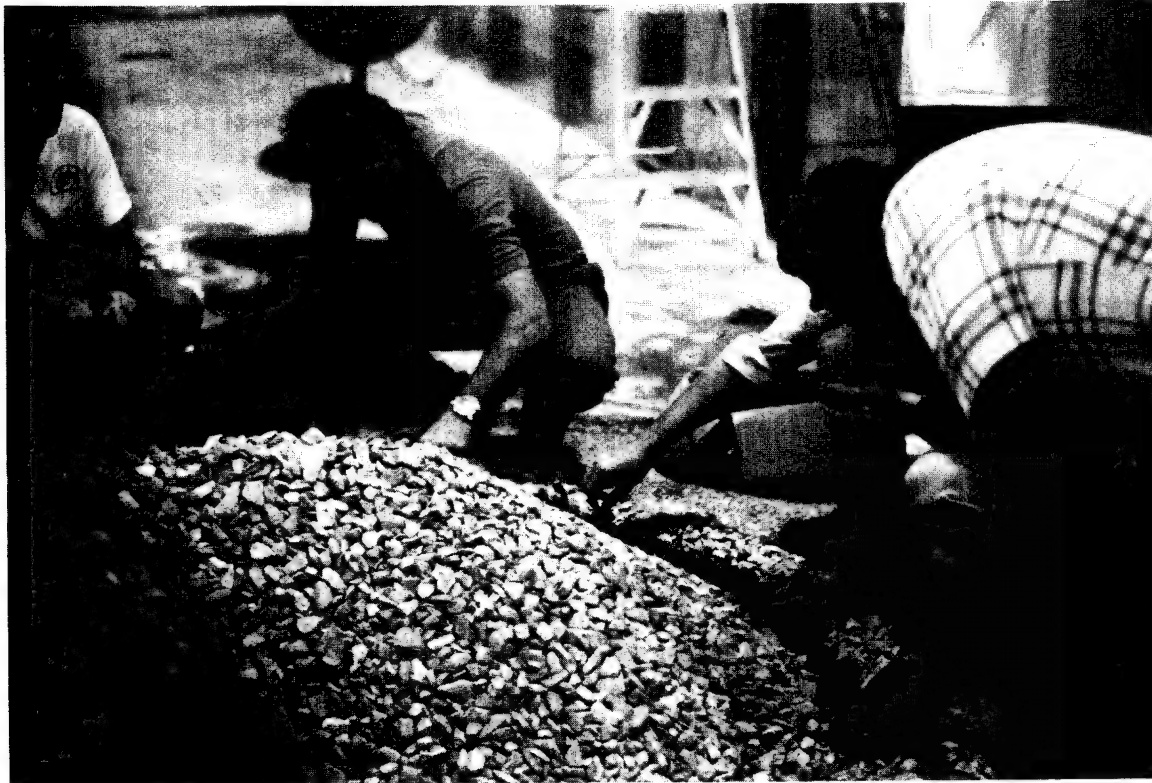
Photo 3. Placement of Core-Loc concrete armor units on model toe

Core-Locs along the toe were placed individually in a uniform pattern as shown in Photo 3. All Core-Locs placed above the toe row were randomly placed. On the harbor side, first row above B-stone also was uniformly placed as at the toe, with all subsequent rows randomly placed.

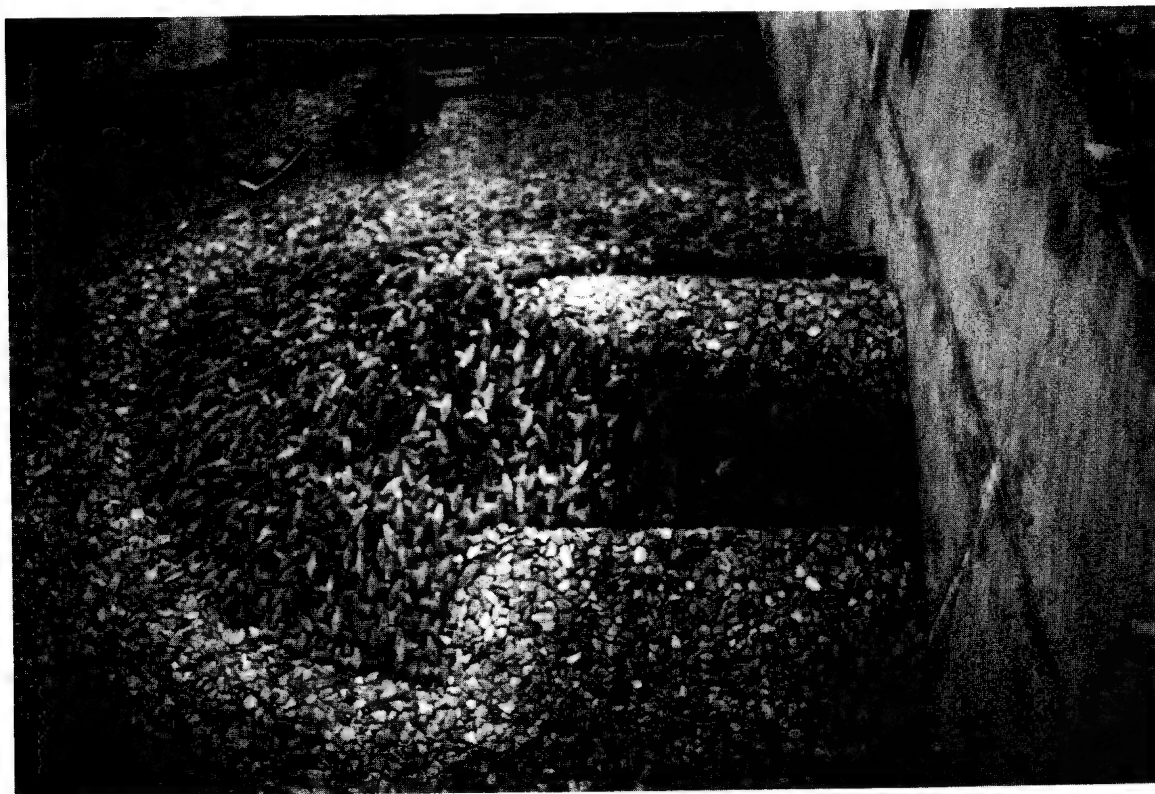
Photo 4. "Inverted V" placement technique for concrete armor units

Placement of Core-Locs on the structure crest followed an “inverted V” (Photo 4). Working from the head back along the crest, Core-Locs were placed in such a manner that they formed a “V” with the point on the crest pointing toward the head. Core-Locs were placed along each side of the structure such that the “V” shape moved along the structure crest from head back along the length of the trunk. This method, recommended by Messrs. Melby and Turk (inventors of the Core-Loc), appeared to produce a more consistent placement of units on the crest and reduced problems with a “seam” that occurs when armor units are placed up each side of the structure and meet at the crest. Where the sides meet, it is difficult to ensure that individual units are keyed into the matrix.

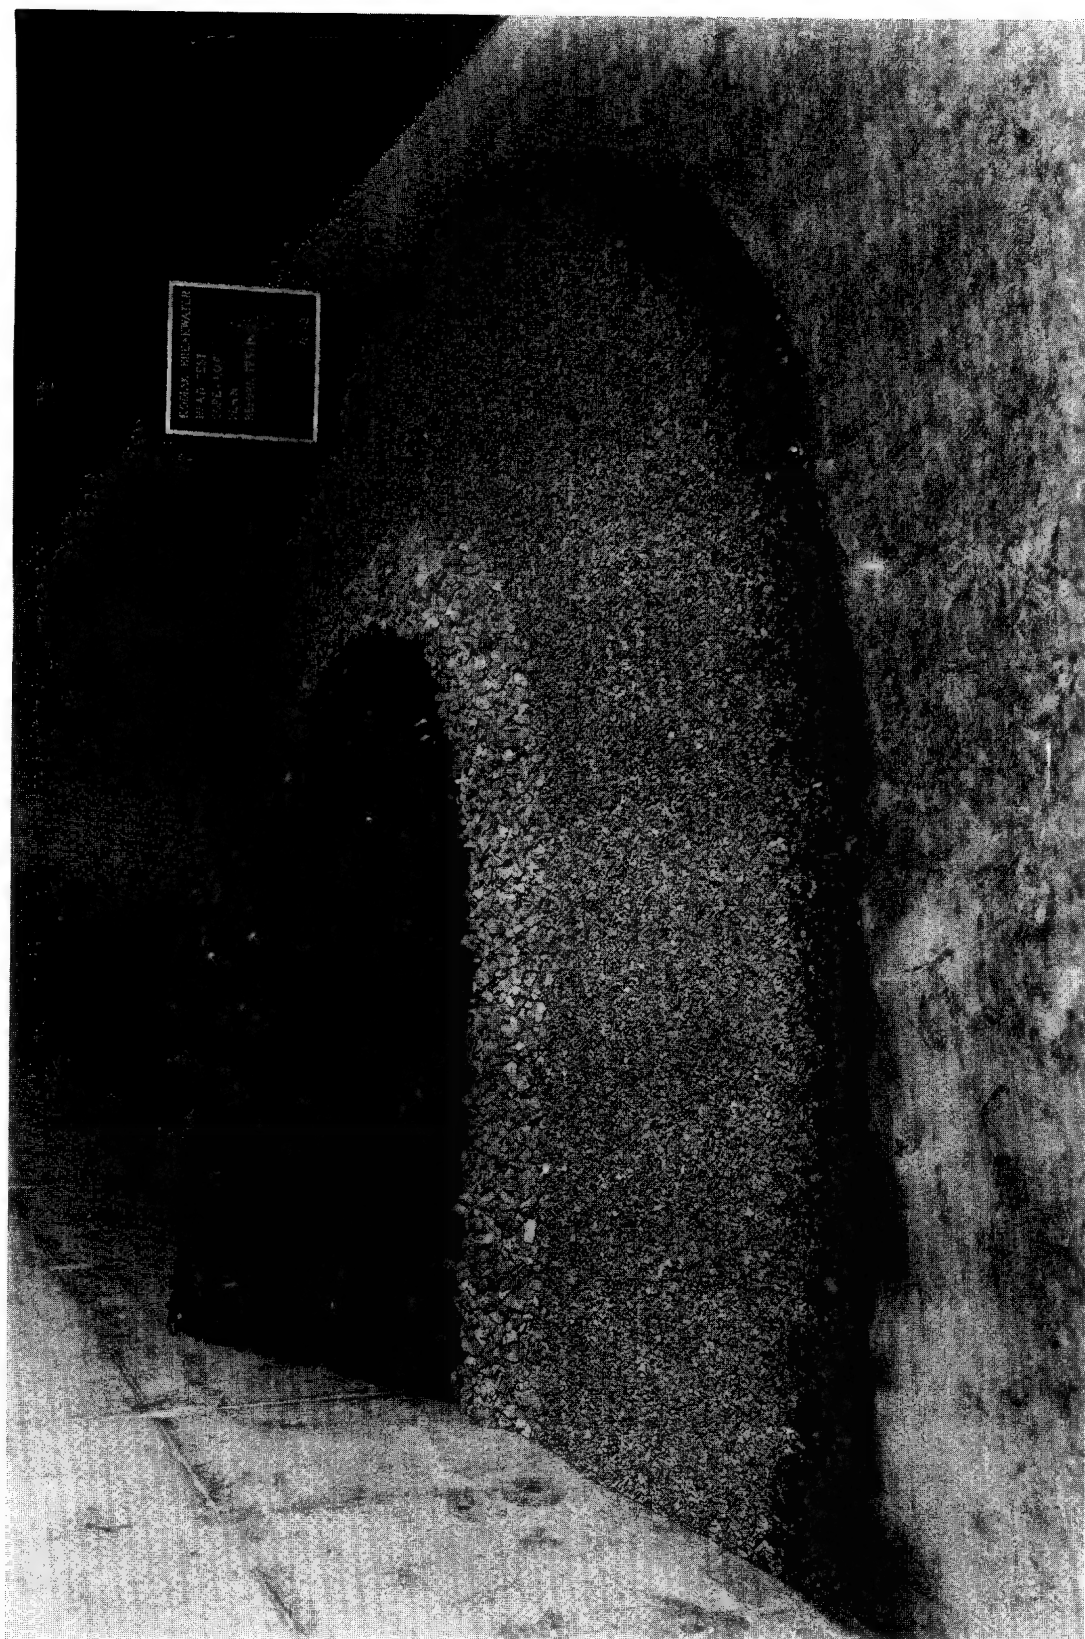
Photo 5. Sea-side view of model breakwater Plan 1 before testing

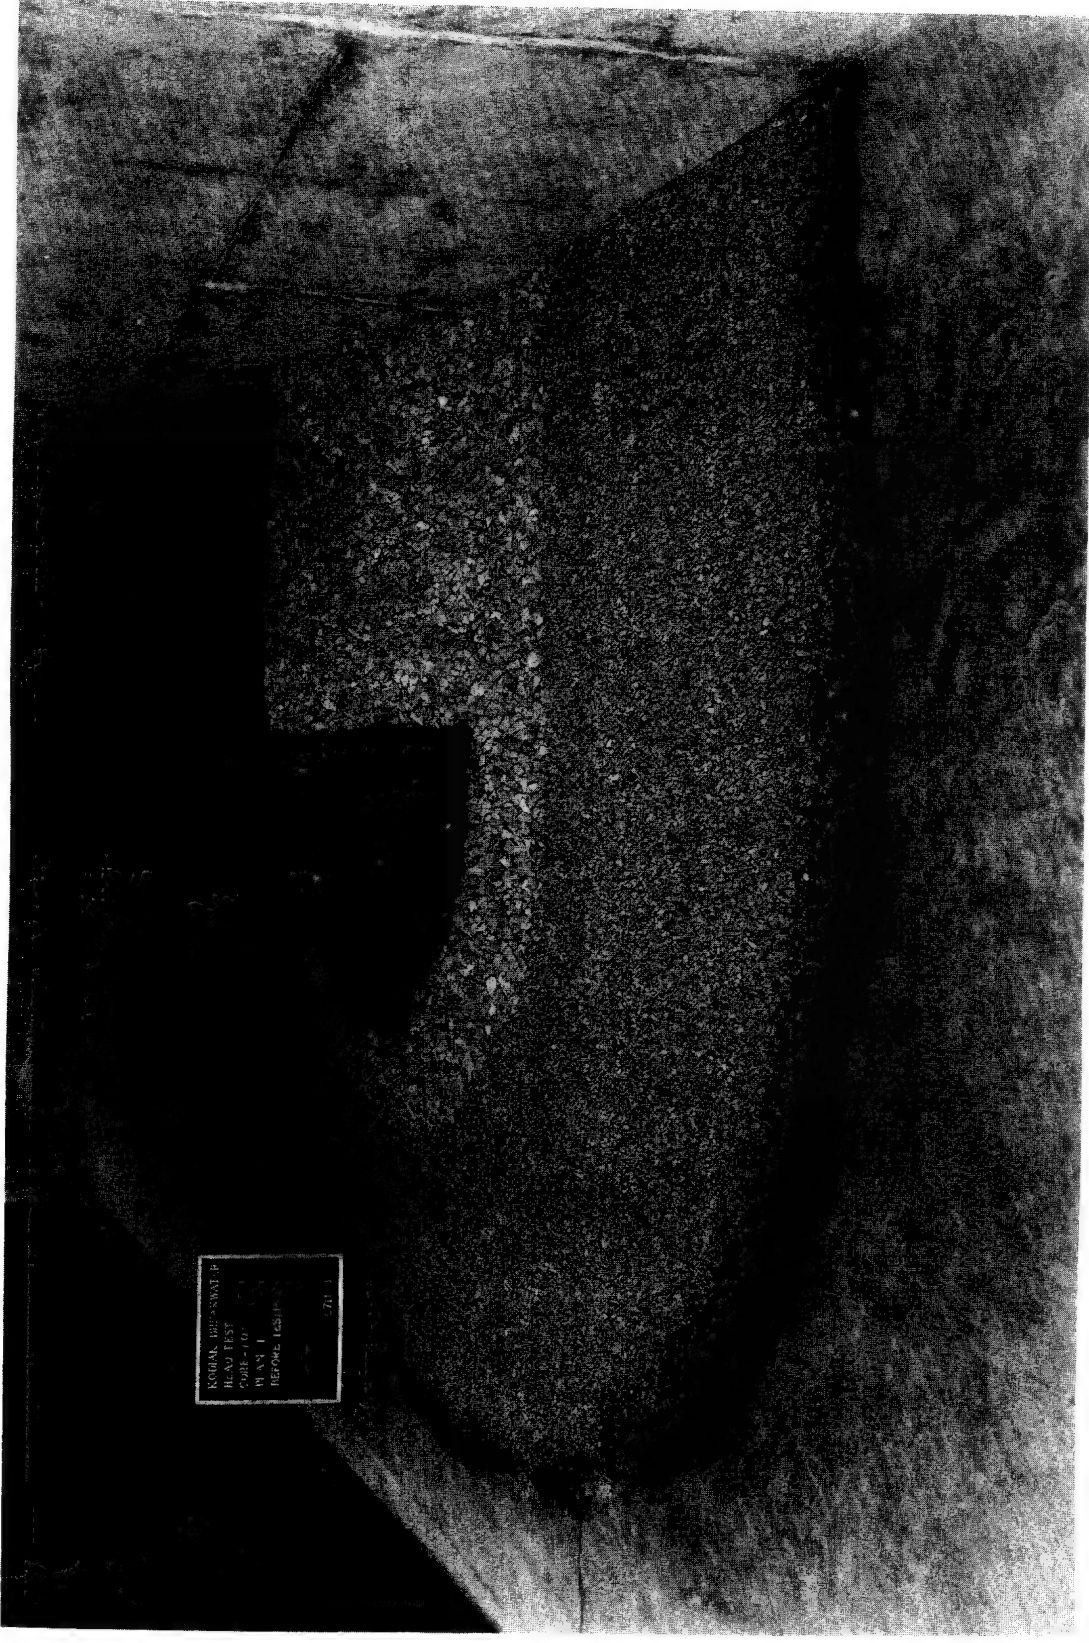
Photo 7. Harbor-side view of model breakwater Plan 1 before testing

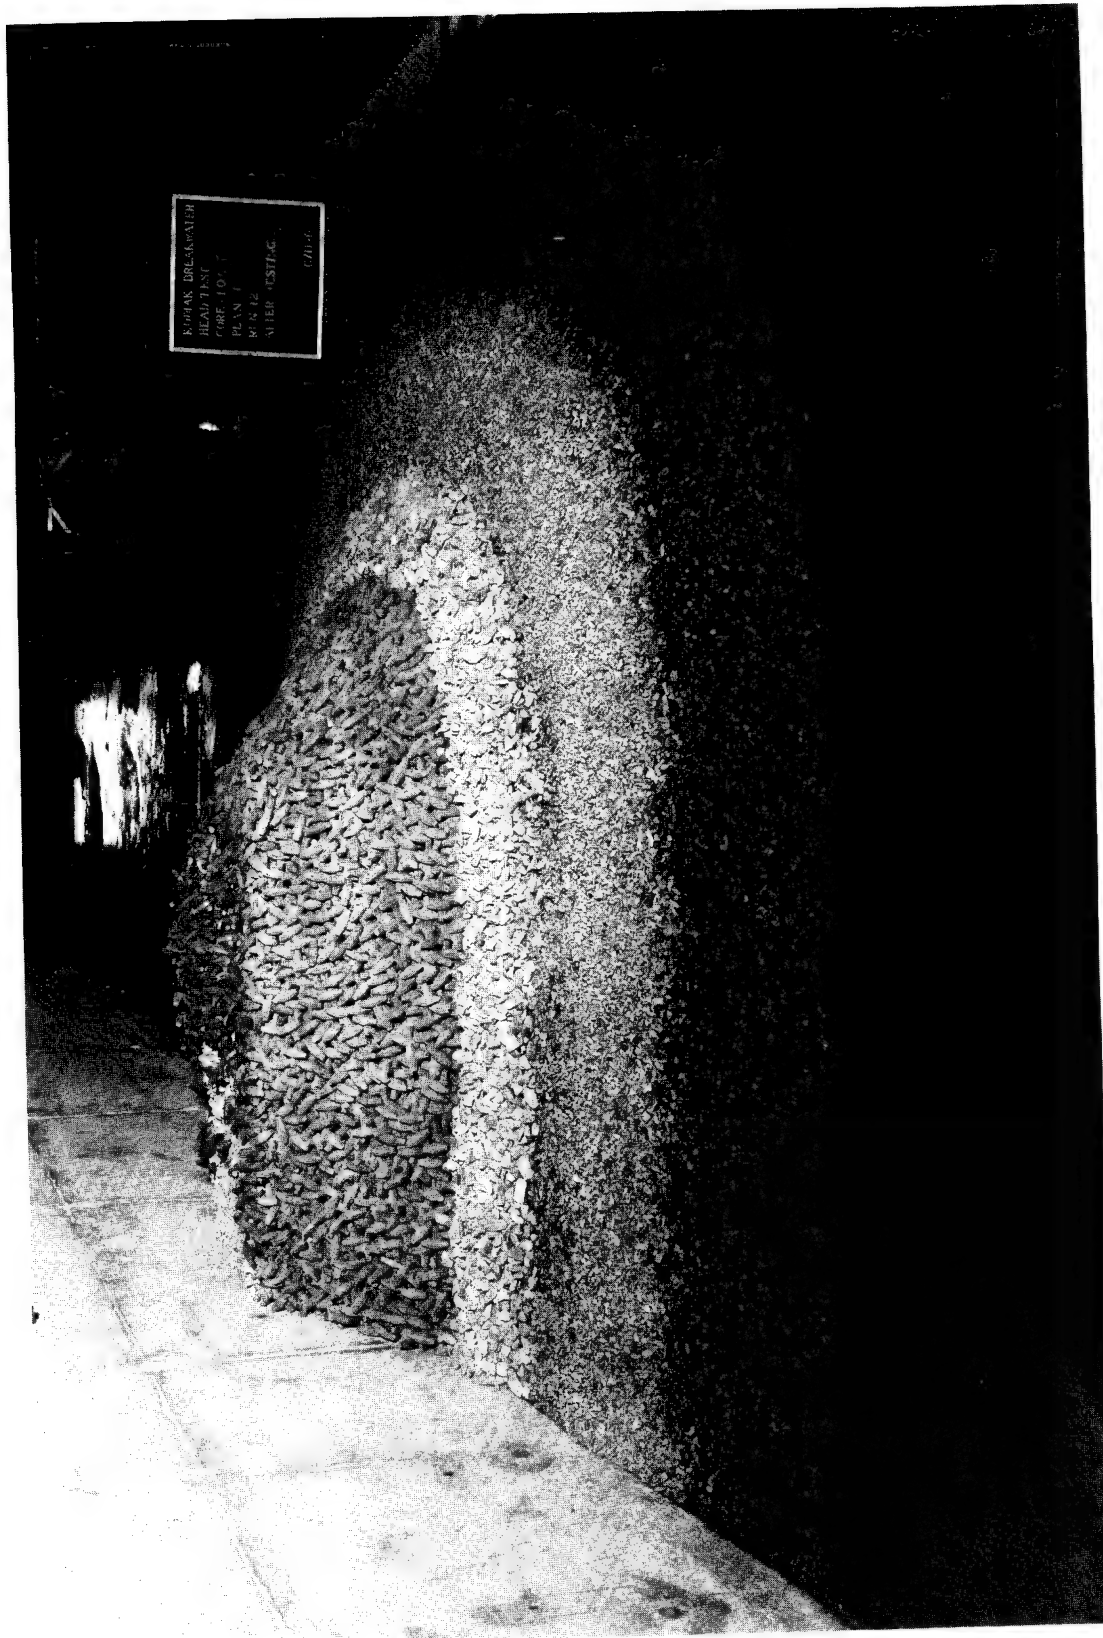
Photo 8. Sea-side view of model breakwater Plan 1 after testing

Due to damage sustained during the first two tests at  $T_p = 7.0$  s and  $H_{m0} = 2.4$  m (8.0 ft), it was decided not to conduct the third test at  $T_p = 7.0$  s and  $H_{m0} = 2.4$  m (8.0 ft), and instead to conduct tests at  $T_p = 11.0$  s and  $H_{m0} = 1.7$  m (5.5 ft). During the first 48-min test at  $T_p = 11.0$  s and  $H_{m0} = 1.7$  m (5.5 ft), B-stone sloughed on the harbor-side trunk, causing a massive failure. Core-Locs on the crest and harbor-side trunk were washed down into the area of the slough and damage extended down to core material. The head was undamaged, and there was no damage to the sea-side trunk below core elevation of 4.0 m mllw (+13 ft). No damage was observed to the toe, apron, or consolidation pad. Photos 8, 9, and 10 show Plan 1 after testing from the sea side, end view, and harbor side, respectively.

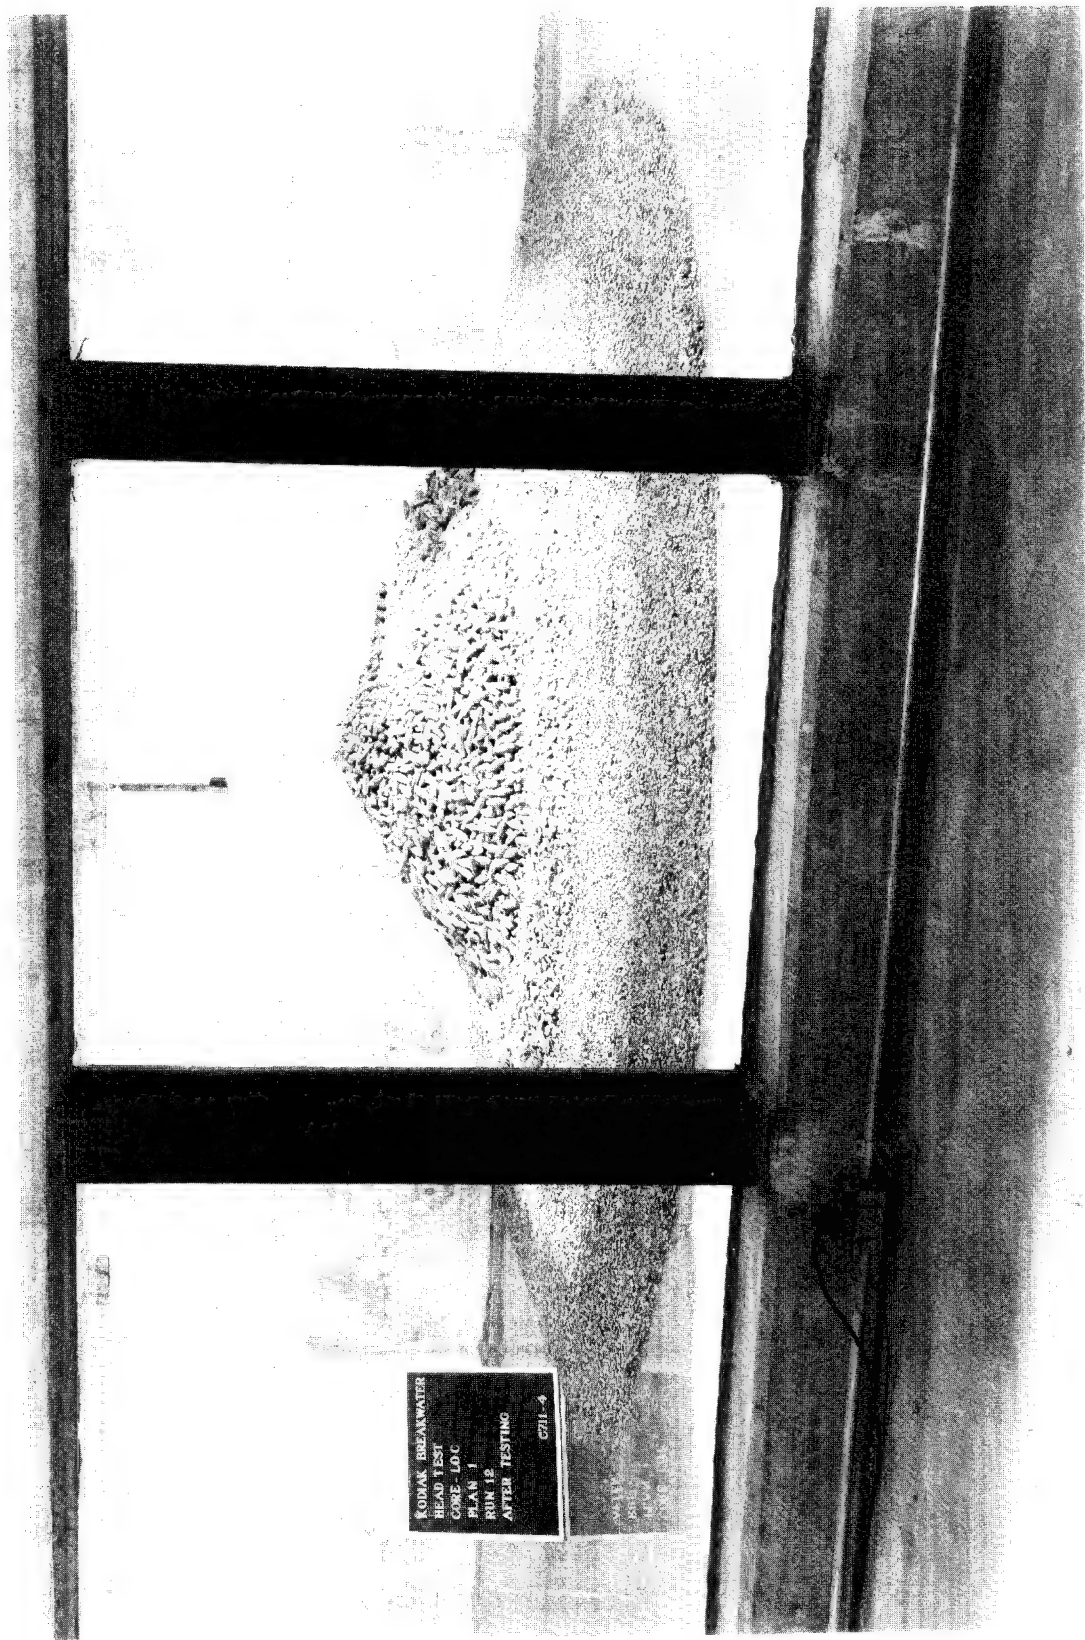
Photo 9. End view of model breakwater Plan 1 after testing

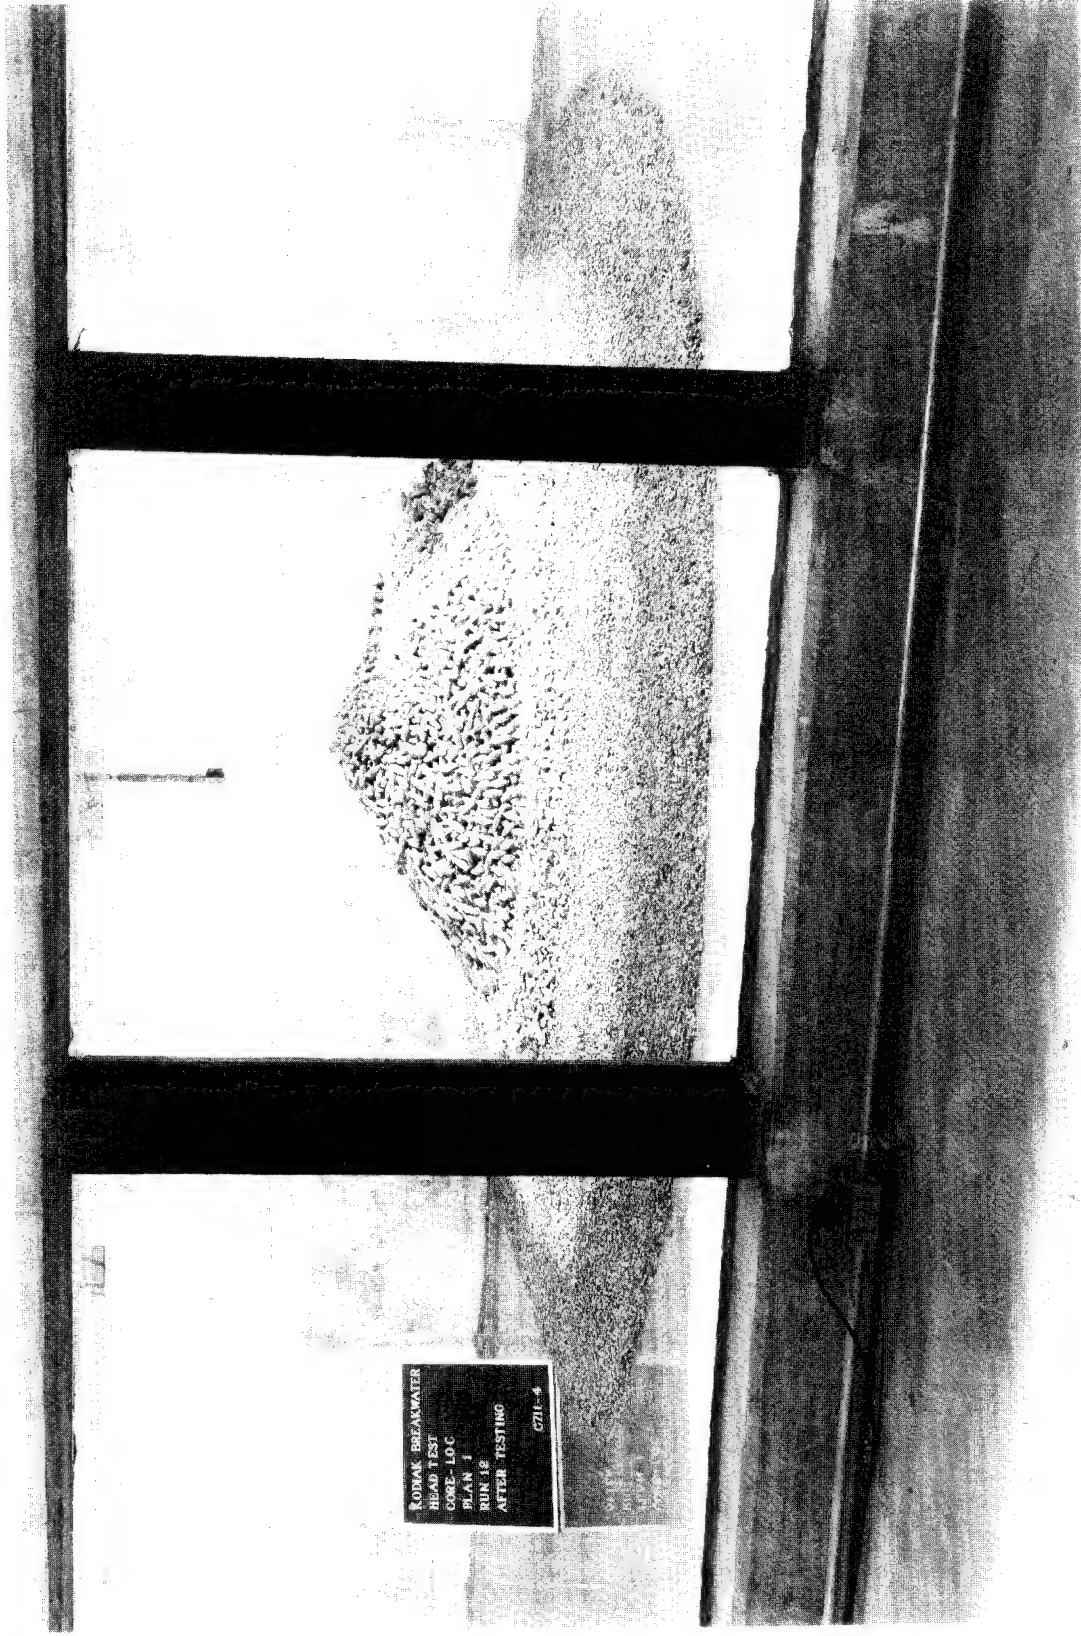
Photo 9. End view of model breakwater Plan 1 after testing

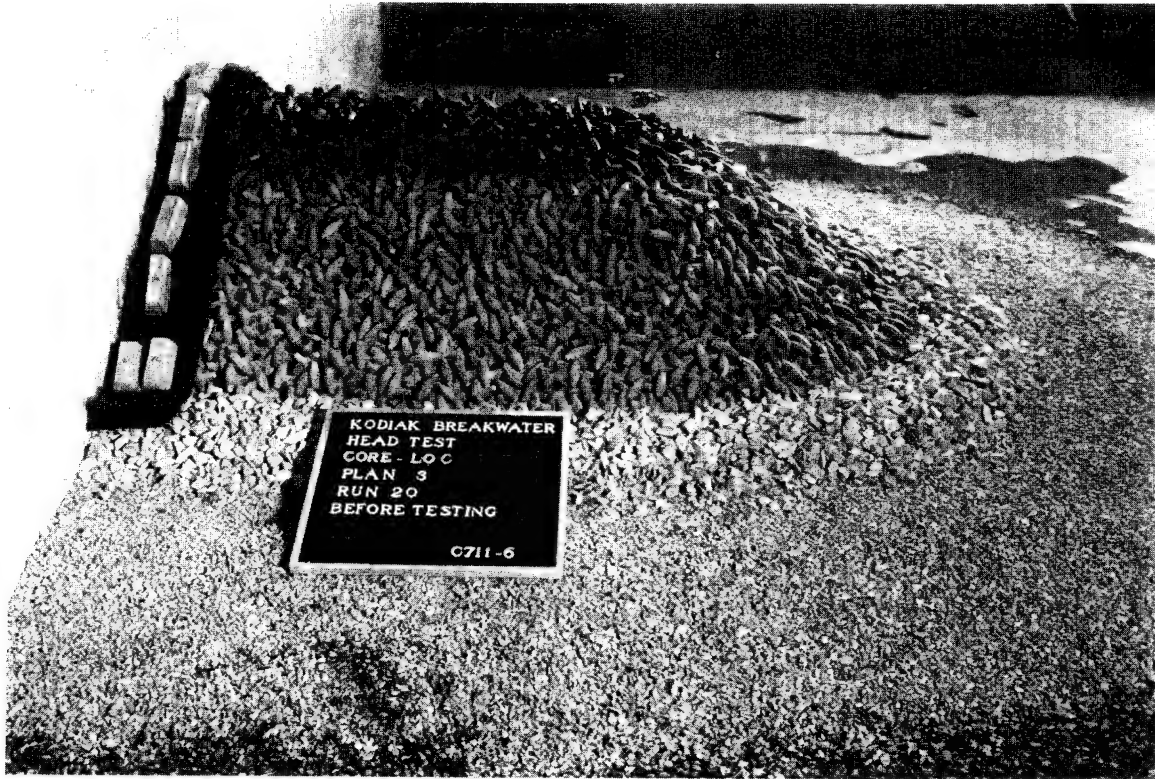
Photo 11. Sea-side view of model breakwater Plan 3 before testing

The sea-side slope and structure head were not rebuilt after Plan 2 testing. All Core-Locs were removed from the crest and harbor-side trunk, and the larger-sized B-stone on the harbor-side trunk were removed. The crest and harbor-side trunk were then rebuilt. Plan 3 used 143 more Core-Loc units than Plan 2 due to placing the Core-Locs further down from the crest on the harbor-side trunk. A strip of horsehair 0.15 m (0.5 ft) wide was placed over the structure along the wall from the sea-side toe to the harbor-side toe to protect units near the wall from wall effects. Photos 11 and 12 show the sea side and harbor side, respectively, of Plan 3 before testing.

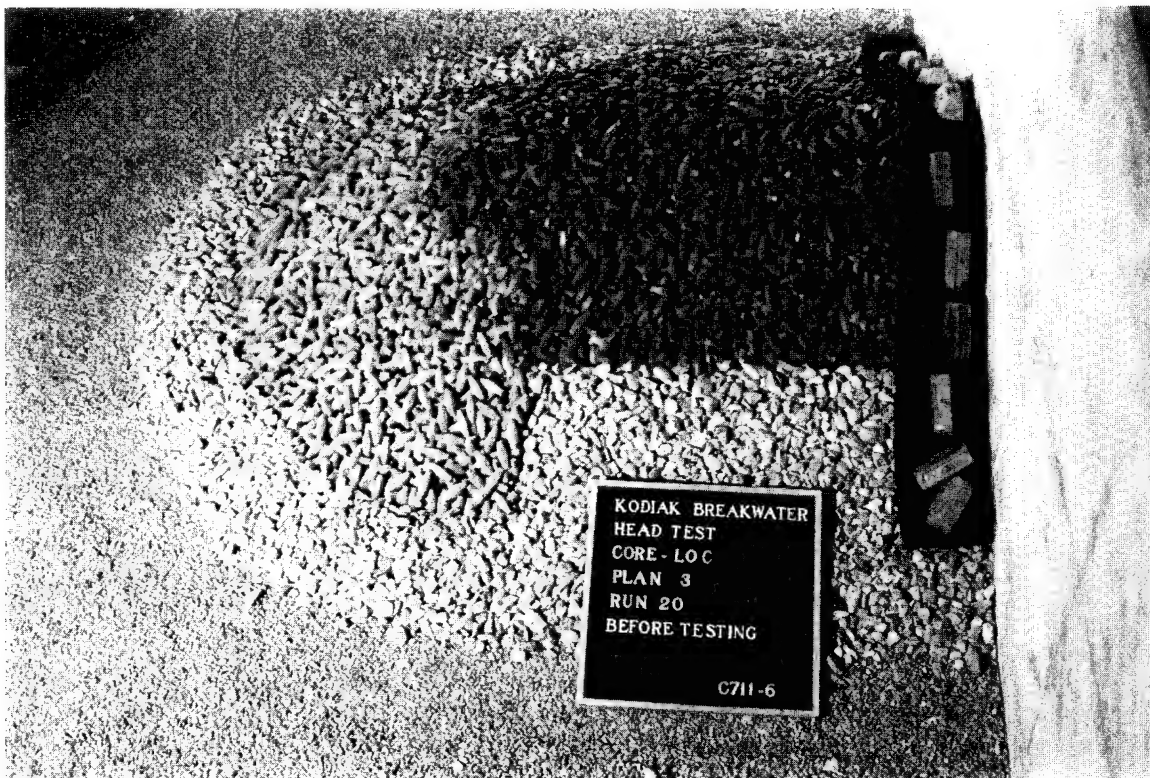
Photo 12. Harbor-side view of model breakwater Plan 3 before testing

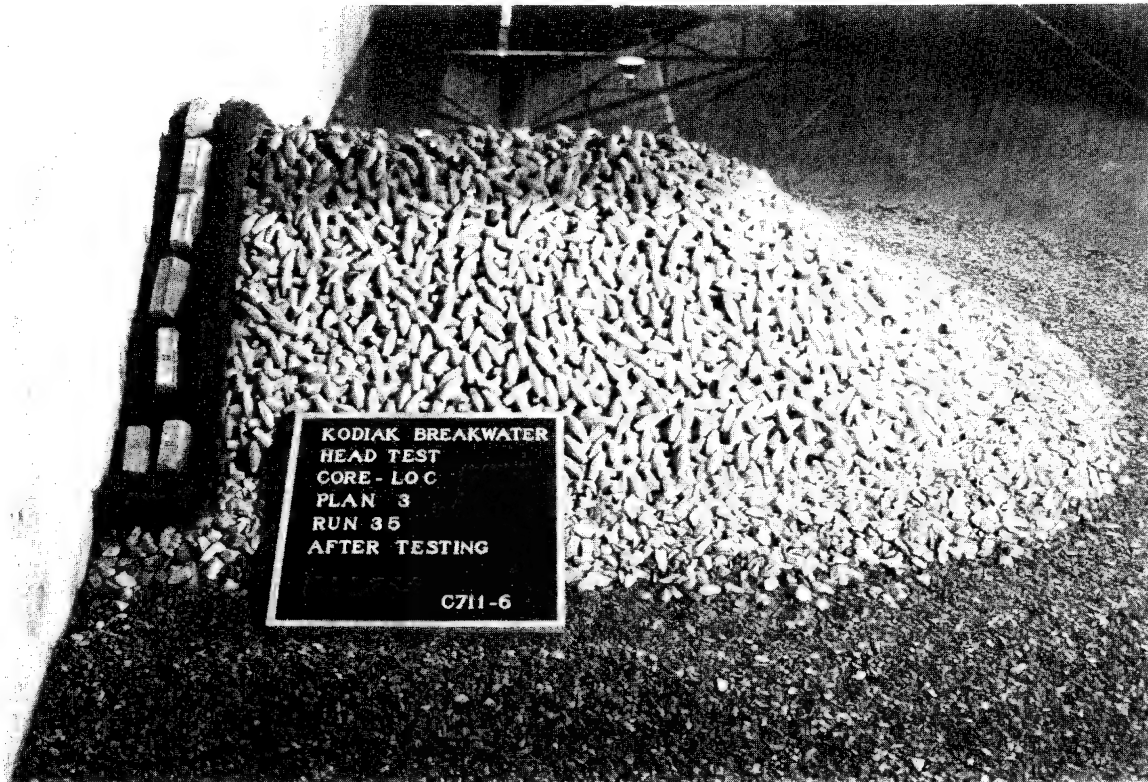
Photo 13. Sea-side view of model breakwater Plan 3 after testing

Three runs of 48 min each were conducted at  $T_p = 14.0$  sec and  $H_{m0} = 2.1$  m (7.0 ft). During the third run, the structure failed when heavy overtopping pushed Core-Loc units down the harbor side of the trunk with enough force to push the B-stone on down the slope in front of the Core-Locs. There was no evidence of undermining. The 14-sec waves overtopped the structure trunk as a surging breaker, causing a very heavy downrush on the harbor side. Because the B-stones were placed by dumping, they were not interlocked into a matrix as is the case with individually placed and seated armor units. The B-stone therefore had little resistance to sliding. Hydrodynamic forces on the Core-Locs were sufficient to push the B-stone downslope and cause a slumping failure in the Core-Locs.

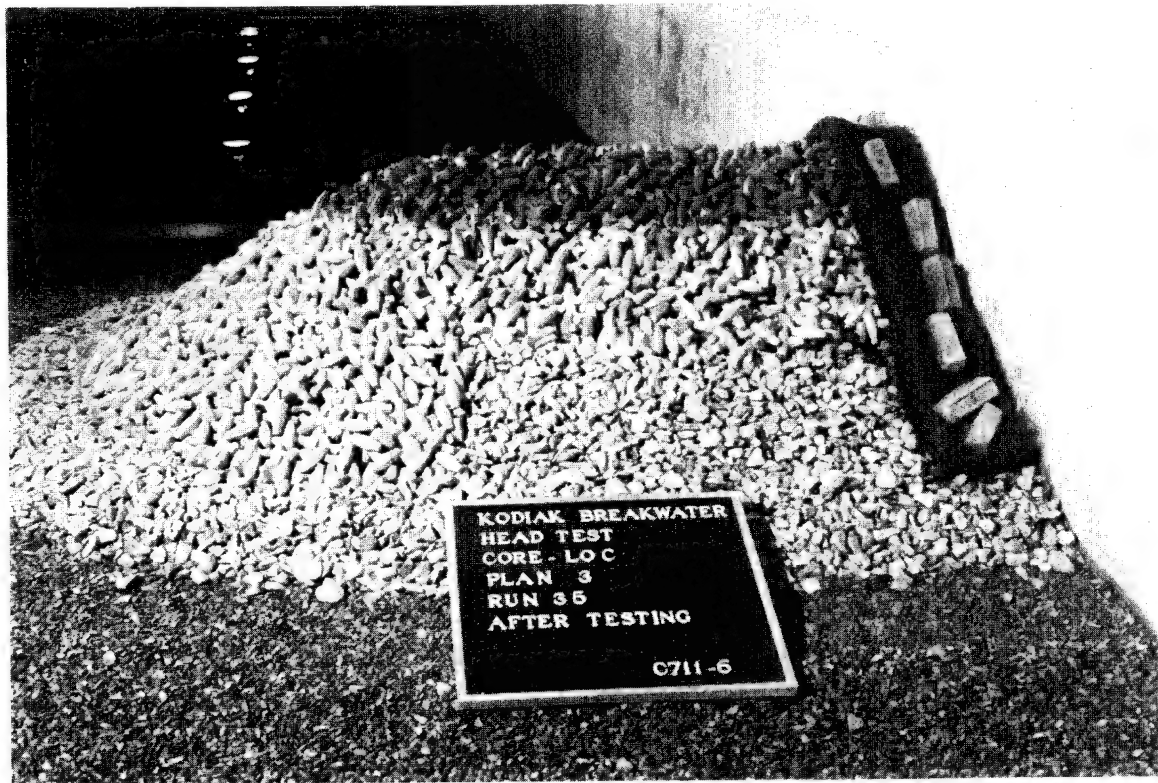
Photo 14. Harbor-side view of model breakwater Plan 3 after testing

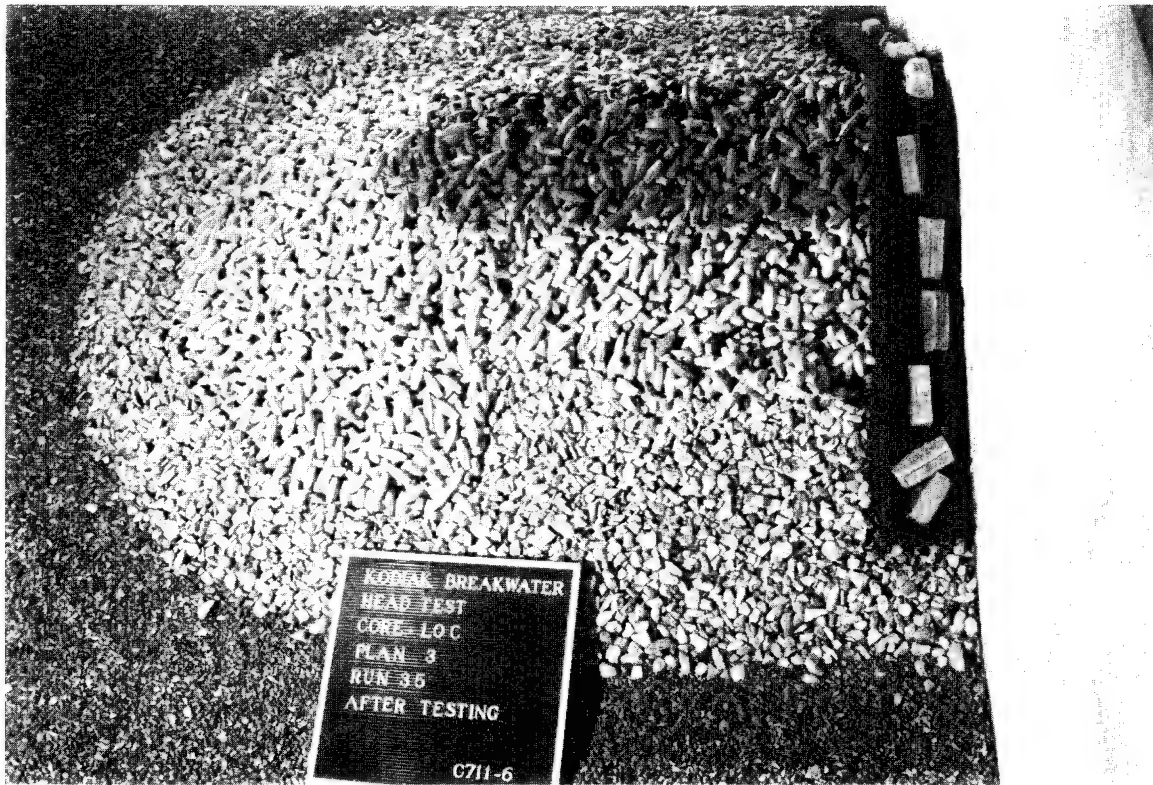
Photo 15. Damage sustained by model breakwater during testing of Plan 3

Until the failure occurred, the only movement observed was one Core-Loc displaced from the harbor-side head. The displaced unit was the same unit displaced in Plan 2. During the rebuild of the crest for Plan 3, the Core-Loc displaced from the harbor-side head was replaced into its original location in the matrix, but apparently was not adequately anchored. Photos 13 and 14 show sea-side and harbor-side views, respectively, of Plan 3 after testing. Photo 15 is another harbor-side view of Plan 3 after testing taken at a higher angle to better display the damage.
